**FEDERAL AVIATION ADMINISTRATION
AIRWORTHINESS DIRECTIVES
LARGE AIRCRAFT**

BIWEEKLY 2006-13

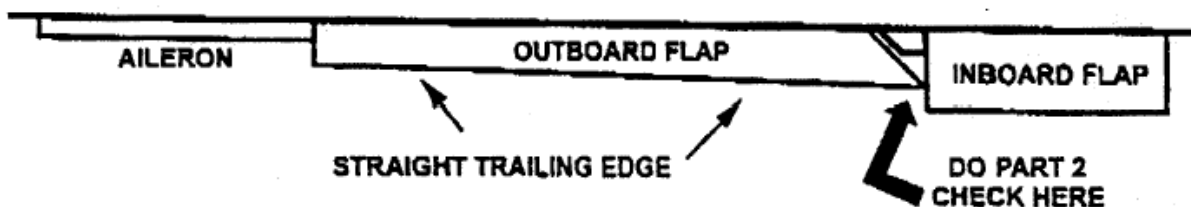
1. NORMAL

A normal outboard flap has a straight trailing edge, and the inboard corner is slightly above (i.e. higher) than the inboard flap.

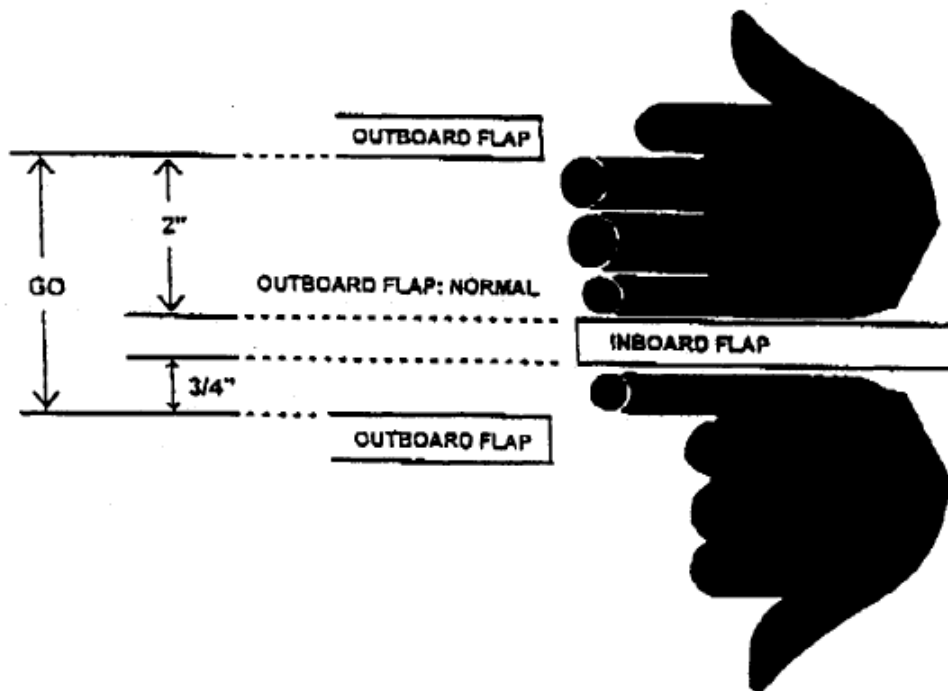
1. FLAPS AT 8 DEGREES

If the outboard flap position is outside the "GO" range as shown below further flight is prohibited.
